DRIVING SAFETY AT SADDLEWOOD INTERSECTIONS

ESTABLISHING A CLEAR LINE OF SIGHT

ESTABLISHING A CLEAR LINE OF SIGHT AT INTERSECTIONS

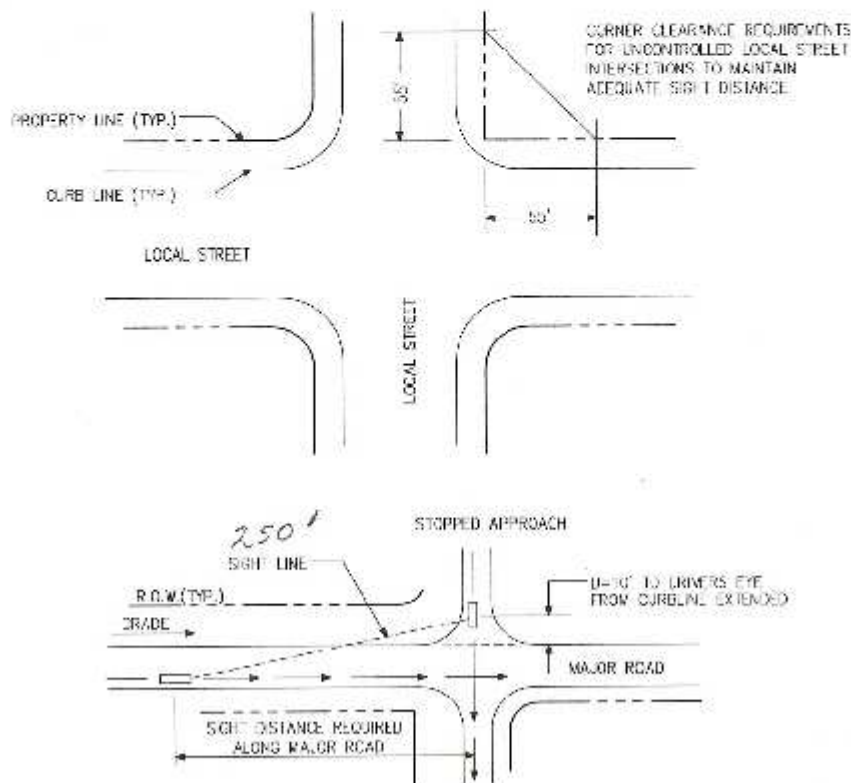
There should be a clear line of sight at an intersection of 250 feet in both directions. See attached drawing on intersection line sight distance.

The pine trees located in the ROW need to be transplanted to another location, trimmed or cut down.

There should be a clear line of sight at an intersection of 250 feet in both directions. See attached drawing on intersection line sight distance. The pine trees located in the ROW need to be transplanted to another location, trimmed or cut down.
